Mobile Intel® Pentium® 4 Processor-M

Specification Update

October 2005

Document Number: 250721-031

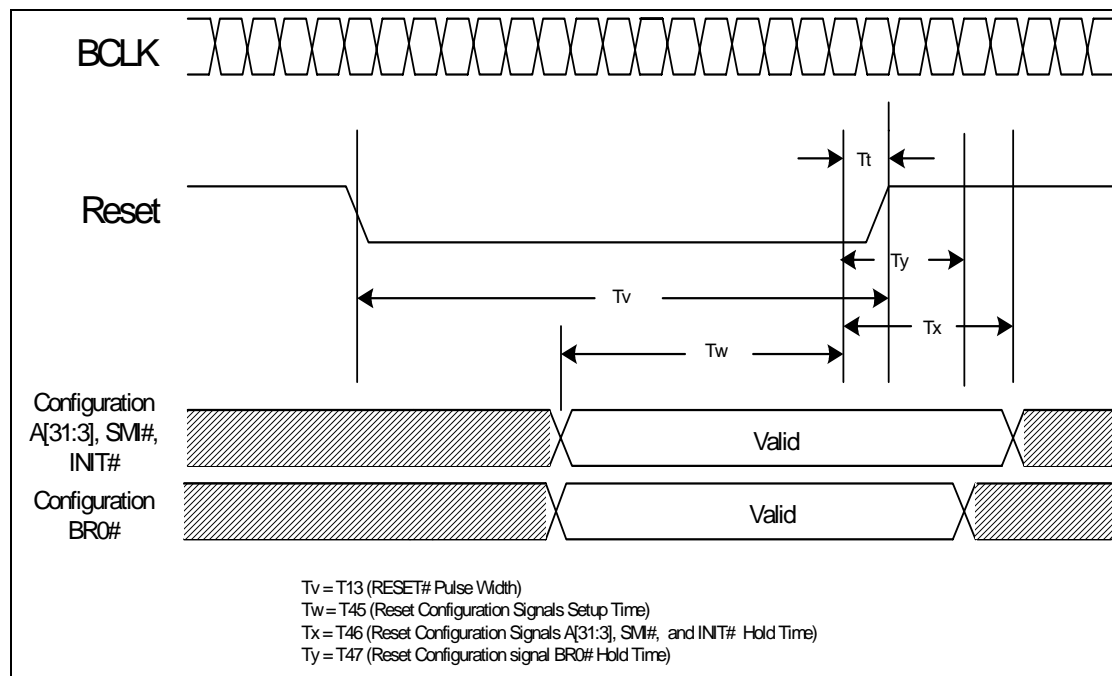
Figure 13. System Bus Reset and Configuration Timings

The BR0# maximum hold time has changed to 2 BCLKs. This change will be shown in the “System Bus AC Specifications (Reset Conditions)” table and “System Bus Reset and Configuration Timings” figure of the *Mobile Intel® Pentium® 4 Processor - M Datasheet*. This change will be incorporated in the next revision of the datasheet.
